SHERIDAN SCHOOL DISTRICT Long Range Facilities Plan

BRIC ARCHITECTURE, INC. OCTOBER 2024

Facility Condition Assessments

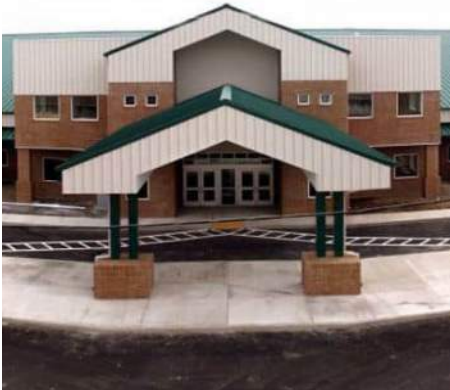
Total Capacity:

Teaching Stations	Qty	Max. Class Size (if used as teaching station)	Utilization Rate	Capacity
General Classrooms - Elementary	21	25	100%	525
General Classrooms / Teaching Stations - Middle	12	28	85%	285.6
SPED	2	15	85%	25.5
MS Music Room	1	28	85%	23.8
Total Capacity	36			860

The Faulconer-Chapman School includes 36 classrooms for a total student capacity of 860 students (kindergarten through 8th grade). With a current enrollment of 484 K-8 students, FCS is at 56% of its total capacity. It is projected that enrollment will slightly increase over the next 10 years, however, enrollment is not projected to exceed capacity during that time span (Figure 3).

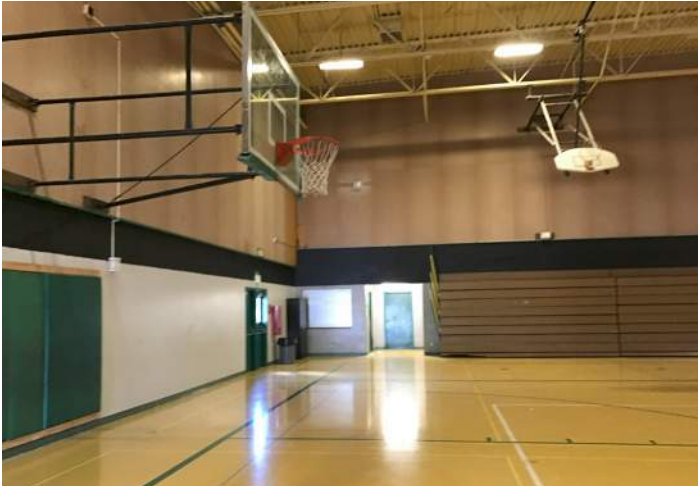
The Faulconer-Chapman school facility is in good condition overall. The FCI score for this school is 10.3%. Key facility condition needs at this site include:

- Plumbing, irrigation, and waste line system replacements.
- Repaint doors, walls, and ceilings.

- Hot water boiler replacement.
- Roof replacement.
- Replace and upgrade aging and/or damaged restroom facilities.
- Window replacements.
- Replace select flooring.
- Repairs to parking lot and roadway surfaces.
- Upgrade science and art room facilities.

Building condition improvement needs for this building are compiled, categorized, and prioritized in the Capital Improvement Plan in Section 8 of this report.

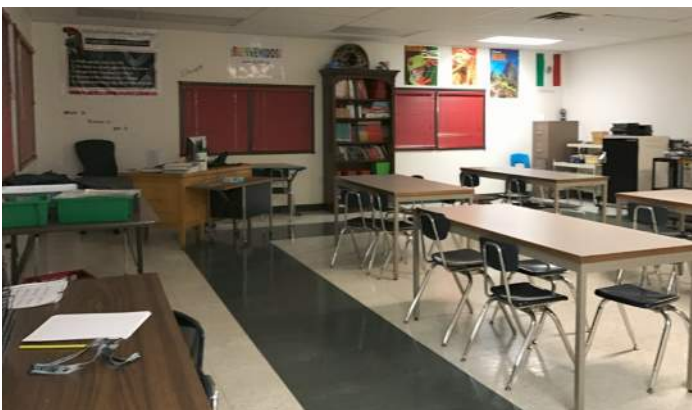
- No makerspace is present. Art instruction, project-based learning and STEAM activities generally occur in classrooms. Elementary classrooms are equipped with sinks and hard surfaced flooring (VCT).
- There is only one science lab available for all middle school grades. The lab has both island and perimeter sinks, and emergency shower, and eye wash. The adjacent prep room is equipped with a ventilation hood. The space requires updates as it has not been in full working order for several years.
- No CTE or specialized elective teaching stations are present.
- Band and music rooms are dated with carpet that is in poor condition. Indoor air quality needs major upgrades (history of leaks, musty odors, etc).

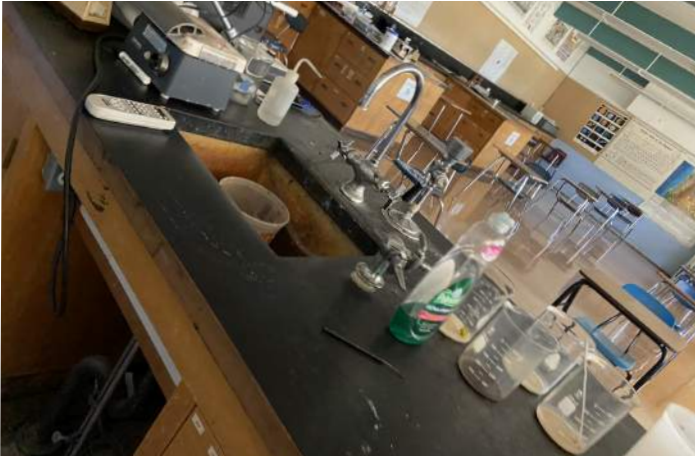
Sheridan High School is in fair overall condition. The FCI score for this school is 14.4%. Key facility condition needs at this site include:

- Repaint doors, walls, and ceilings.
- Building systems such as plumbing fixtures, mechanical units and electrical panels are at the end of their useful life and due for replacement.
- Replace/upgrade food service equipment in kitchen and in vocational classrooms.

- Flooring and carpet replacements throughout the school.
- Remodel science classrooms.
- Upgrade art rooms and stage equipment.
- Replace roofing and skylights.
- Remodel aging toilet rooms.
- Repave roadway and parking lots and update ADA ramps.
- Replace clock and intercom systems.

Building condition improvement needs for this building are compiled, categorized, and prioritized in the Capital Improvement Plan in Section 8 of this report.

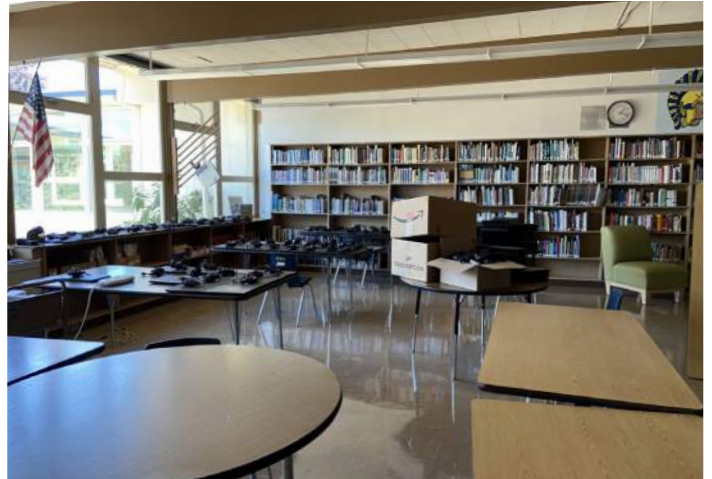
- The school has two (2) gyms. The “old” gym had significant seismic retrofits - bracing is present in the middle of the floor limiting the use of the space. This space is not typically used for P.E. instruction but is used for extra-curricular activities and wrestling. The new gym is functional with an integrated sound system and stage. Locker rooms in the old gym are “terrible and musty.”
- The commons area is adequately sized with a stage. The school operates one (1) lunch period and has an open campus. The serving line reportedly becomes congested. The stage needs safety and lighting upgrades.
- The library media center is dated in appearance and uninviting. Large windows provide ample daylighting.

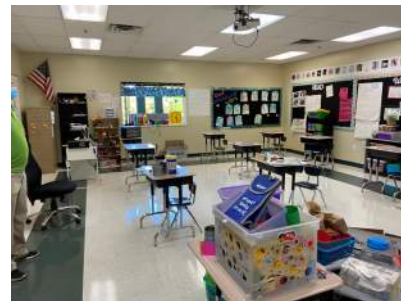
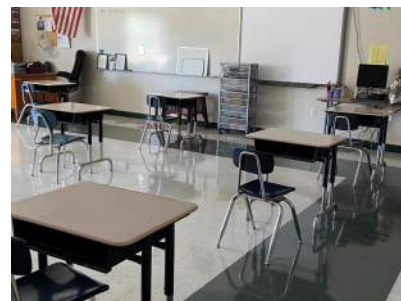
- Classroom sizes are generally sufficient. Sinks are present in elementary classrooms. Most elementary classrooms have their own dedicated single-use restroom. Aging audio visual equipment is due for replacement.
- Limited daylighting in classrooms (one small window per classroom). Interior lighting is outdated and in need of upgrade to LED.
- Very wide temperature fluctuations between classrooms. Classroom windows are not operable. Acoustics between classrooms are reportedly inconsistent, with noise transmission issues in some areas.
- Classroom furniture is aging and due for replacement. Cracked flooring and walls are visible in areas, as well as stained ceiling tiles.

- Classroom sizes are generally sufficient, and most include their own dedicated single-use restroom. Daylight is limited in the classrooms, the windows are not operable, and there is a lack of view to the outdoors.
- The audio/visual equipment are aging and due for replacement.
- Interior lighting is dated (not LED).
- Acoustics quality is inconsistent between classrooms, with noise transmission in some areas.
- There are drastic temperature fluctuations between classrooms which makes it challenging to maintain consistent and comfortable thermal conditions in classrooms.
- The furnishings are older and deteriorating.
- Cracked flooring, walls, and stained ceiling tiles in need of replacement.

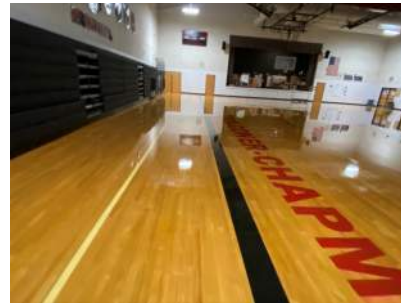
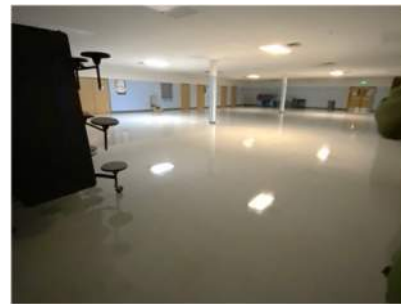
- Two (2) gyms are present: a main gym in the new building and an old aux gym in a separate older building. The old gym's flooring is in very poor condition, to the point of being a tripping hazard. The new gym's flooring is due for refinishing. Nearby restrooms are dated and in poor overall condition.
- The kitchen/servery reportedly operates efficiently. The school holds two (2) middle school lunch periods followed by a series of staggered elementary lunches where classes of students arrive every 15 minutes. The cafeteria is not a visually inviting space, with low ceilings and no natural light. The size of the cafeteria is inadequate if the school were to move to a schedule with fewer lunch periods.
- The library media center is dark and uninviting. Shelving takes up much of the floor area leaving little space for flexible furnishing arrangements or collaborative activities.

- There are two gymnasiums present: a main gym in the new building, and an old standalone aux gym. The old gym's flooring is in very poor condition, causing tripping hazards. The new gym's flooring is in need of refinishing. Nearby restrooms are dated and in poor overall condition.
- The school serves two (2) middle school lunch periods followed by a series of staggered elementary lunches where classes of students arrive every 15 minutes. The kitchen reportedly operates efficiently, but the cafeteria is not a visually inviting space, with low ceilings and no natural light. The cafeteria would be inadequately sized if the school chose to schedule fewer lunch periods.
- The library media center is dark and uninviting. Shelving takes up majority of the floor space leaving little room for flexible furnishing arrangements or collaborative activities.

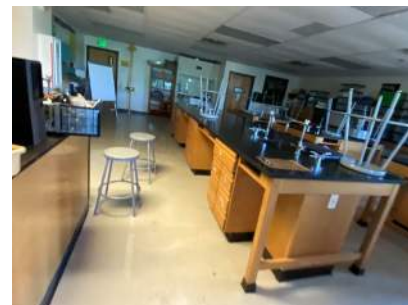
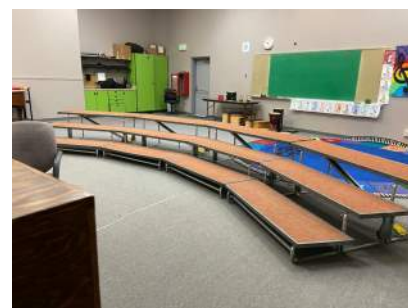
- No makerspace is present. Project-based learning and STEAM activities generally occur in classrooms. Elementary classrooms are equipped with sinks and hard surfaced flooring (VCT).
- There is only one science lab available for all middle school grades. The lab has both island and perimeter sinks, an emergency shower and eye wash. The adjacent prep room is equipped with a ventilation hood. However, the space has not been in full working order for years, requiring updates.
- No CTE or specialized elective teaching stations are present.
- Band and music rooms (at old gym) are very dated with carpet in poor condition and poor indoor air quality (past leaks, musty odor, etc.).
- A general classroom is used for art instruction.

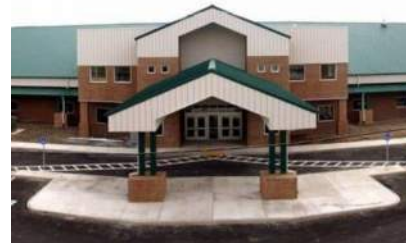
- Although an entry vestibule is present, visitors are not able to be diverted into the main office before proceeding into the building. This presents a security vulnerability as staff are not able to intercept unauthorized visitors.
- The camera system is outdated and inadequate in terms of coverage. An addressable fire / security alarm system is needed.
- A dedicated bus loading / unloading area is desired on the south side of the campus. Sidewalk repairs and ADA ramps are needed.
- Additional exterior lighting is needed along pathways and in the parking lot. Card readers are desired on additional exterior doors and gates.
- Concern over the safety of the playground surfacing, as well as the age of some of the playground equipment.

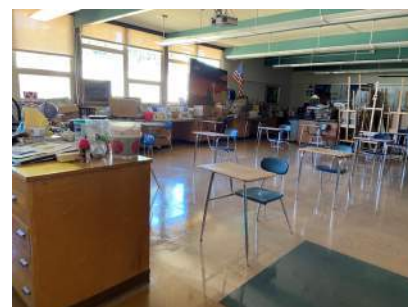
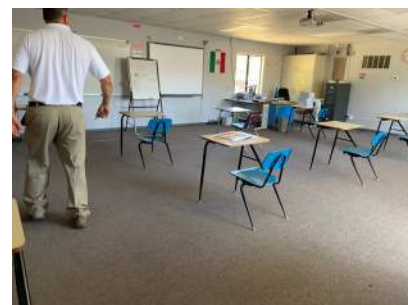
- Classroom sizes are not uniform; some are smaller than others. Old and outdated student furnishings are not conducive to flexibility. Aging finishes are present.
- Only three (3) of the five (5) portable classrooms onsite are suitable for instruction. All are in need of roof replacements and new flooring.
- Classrooms have expansive (operable) windows with ample natural light. However, central A/C is not present in this building; Only 2 or 3 classrooms are serviced by split unit air conditioning. Classrooms can be excessively warm in early fall and late spring months. Lighting is outdated and in need of upgrade to LED.

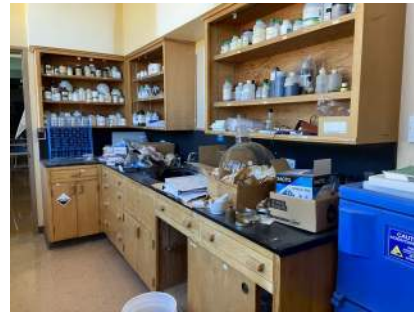
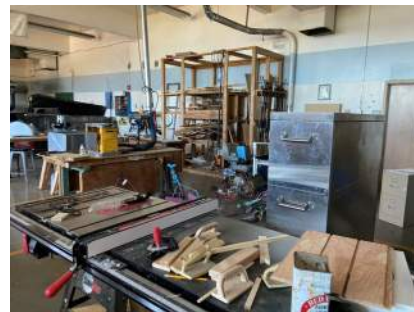
- Only one true science lab (by design) is present; general classrooms are also used for science instruction. The single “true lab” is very dated with countertops severely lifting to the point that it inhibits safe usage. Sinks are stained and discolored. A hood is present in the prep room only. Its poor condition makes it “useless” for science instruction.
- CTE classes include business, agriscience/horticulture, and animal science. The horticulture program is particularly successful; the onsite greenhouse is used to grow vegetables for purchase by the community. A shop is present. The former home economics classroom is used for general instruction; it would require significant updating to be used for its intended purpose.
- An art classroom was adapted using Measure 98 funds. Two general classrooms were converted into a makerspace.

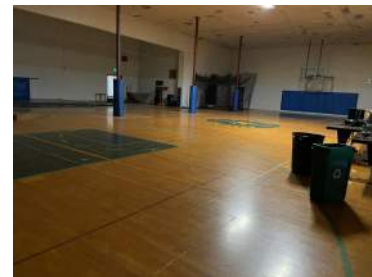
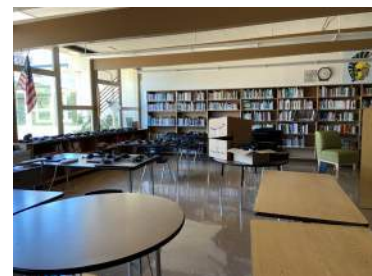
- The school has two (2) gyms. The “old” gym had significant seismic retrofits - bracing is present in the middle of the floor limiting use of the space. This space is not typically used for P.E. instruction, but is used for extra-curricular activities and wrestling. The new gym is functional with an integrated sound system and stage. Locker rooms in the old gym are “terrible and musty.”
- The commons is adequately sized with a stage. The school operates one (1) lunch period and has an open campus. The serving line reportedly becomes congested at times. The stage is in need of safety and lighting upgrades.
- The library media center is generally dated in appearance and uninviting (though it has nice daylighting).

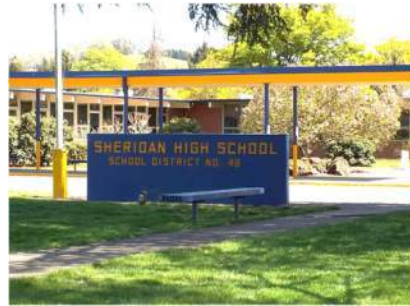
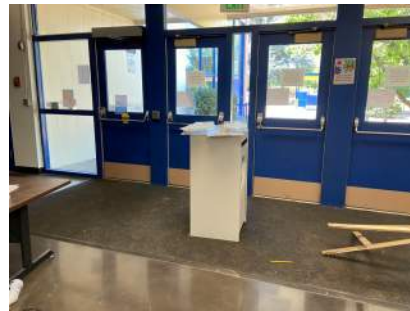
- A secure entry vestibule is not present at the main entry, creating a security vulnerability as visitors can walk into the building without being intercepted by staff.
- The school is not zoned for after-hours use.
- The aging PA system is in very poor condition and cannot be heard in many classrooms, corridors, or outside the building.
- Additional exterior lighting is needed.
- Bollards needed at front entrance and south entrance.
- Fire life safety upgrades are needed. Very outdated camera system with inadequate coverage. An addressable fire / security alarm system is needed.
- The porous campus has incomplete fencing opening along the adjacent railroad tracks.
- Expanded parking is needed.
- Exterior ADA ramps needed for accessible routes to building.
